Accessibility Research Group
Civil, Environmental, and Geomatic Engineering
University College London

commissioned by
Transport for London

Shared Space Delineators

Are They Detectable?

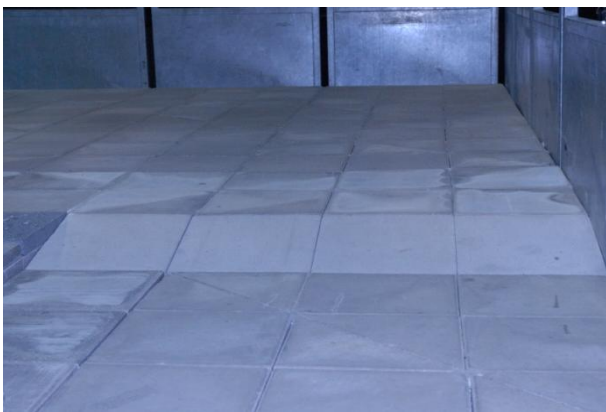
Figure 2 Single Slope

Figure	Code	Delineator Surface Description	Profile Height (mm)	Height (mm)	Width (mm)	Figure 1 location
2	SS	Single Slope 1:5	0	80	400	1
3	CD	modified Central Delineator as used to separate bicycles from pedestrians in shared lanes	150	20	150	4
4	RoRu	Rough Rumble paving with irregular surface	20 max	0	400	2
5	B.4	Blister 400mm wide	6	0	400	5
6	RiRu	Ridged Rumble paving with regular '^' shaped ridges	15	0	400	3
7	DS	Double Slope 1:7 with 200mm valley in-between two 400mm slopes	0	1200	6

In Layout 1 the Single Slope (SS) was too steep and the combination of slopes in the Double Slope (DS) delineator was too difficult for some MI participants to get over. In Layout 3 a surface sloping at 1:24 with non-chamfered pavers was not reliably detected (69 out of 96 fails). There were subjective responses indicating that a slope could still be a good delineator if less steep (than 1:7) and indicated by another delineator at the top. It was thought that this additional delineator would both warn blind and partially sighted people that the slope was there and that the combination indicated a change of space. This resulted in the inclusion in Layouts 2 and 3 of the combined Corduroy profiles, with a level surface and a sloped surface. The Corduroy Hazard Warning Paving combined with a slope was effective for detection and resulted in Overpass scores comparable to the Blister paving for all conditions tested except the Corduroy top and Corduroy on a 1:8 slope (Layout 2).

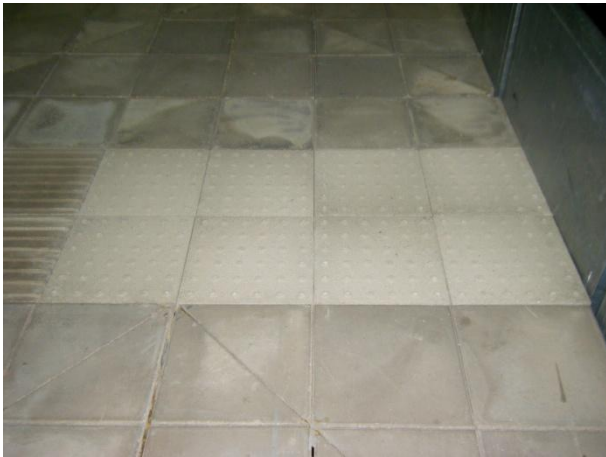
Figure 8 Blister

Figure	Code	Delineator Surface Description	Profile Height (mm)	Height (mm)	Width (mm)	Figure 1 location
8	B	Blister	6	0	800	1
9	CC 8	Corduroy Warning one paver width level with surrounding pavers and one paver at 1:8	6	50	800	4
11	CF 8	Corduroy Warning one paver width level with surrounding pavers and one non-chamfered paver at 1:8	6	800	5	
10	C	Corduroy Hazard Warning	6	0	800	2
12	C6	Corduroy Warning raised above surrounding pavers	15	6	800	3
13	FC 8	Corduroy Warning one paver width at 1:8	6	50	400	6

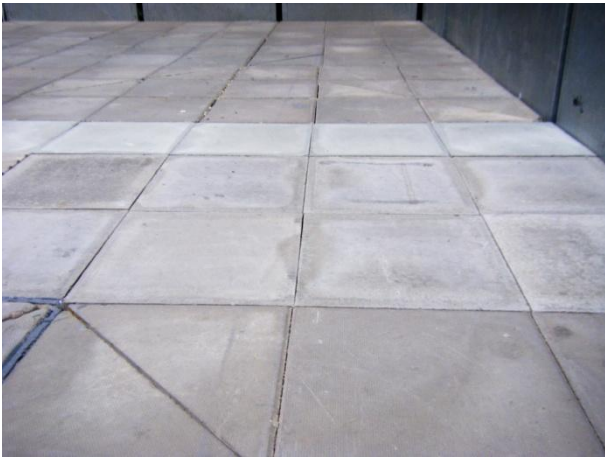
Figure 14 non-chamfered pavers at 1:24 slope

Figure	Code	Delineator Surface Description	Profile Height (mm)	Height (mm)	Width (mm)	Figure 1 location
14	nC 24	Non-chamfered pavers at 1:24	0	33	800	1
15	CC 12	Corduroy Warning one paver width level with surrounding pavers and one paver at 1:12	6	33	800	4
16	C 24	Corduroy Hazard Warning at 1:24	6	33 <td 800	2	
17	CF 12	Corduroy Warning one paver width level with surrounding pavers and one non-chamfered paver at 1:12	6	33	800	5
18	B 24	Blister at 1:24	6	33	800	3
19	FC 12	Corduroy Warning one paver width at 1:12	6	33	400	6

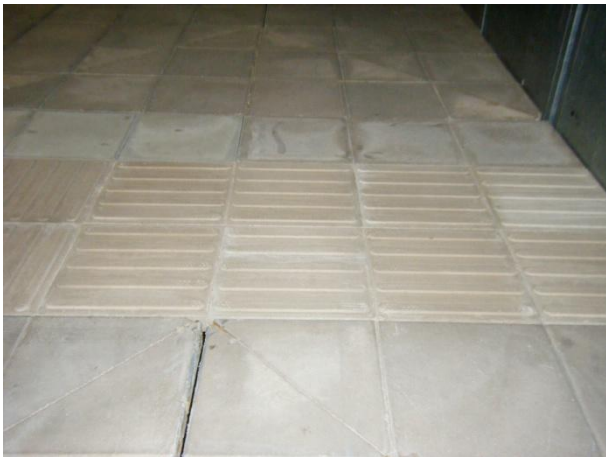
Figure 20 Guidance paving

Figure	Code	Delineator Surface Description	Profile Height (mm)	Height (mm)	Width (mm)	Figure 1 location
20	G	Guidance Path Surface Paving	6	0	800	1
21	B	Blister	6	0	800	4
22	Gpll	Guidance Path Surface Paving aligned to cross the road	6	0	800	2
23	Md	Dome set above surrounding surface	15	0	800	5
24	Cpll	Corduroy Warning aligned to cross the road	6	0	800	3
25	Hd	Dome set below surrounding surface	10	0	800	6

Layout 4 included Guidance Path Surface Paving both perpendicular and parallel to the direction of crossing the road. The direction of the delineator does matter. Guidance Path Surface Paving in line with the direction of walking being difficult for many participants to detect (22 out of 100 trials) and Corduroy Hazard Warning Paving being detected fewer times in this orientation than for other layouts.
